---

**Prepared By:**

**Report Number:**

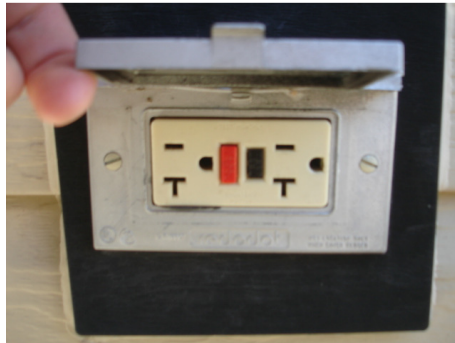
GFCI will not trip in the front of home.

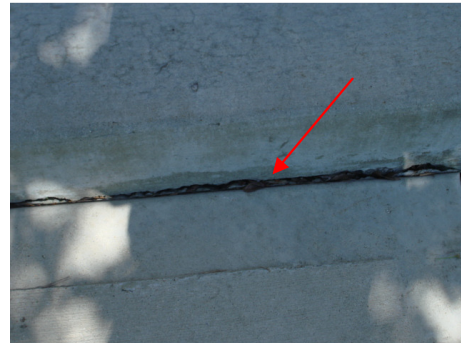
Seal step and front walk crack.

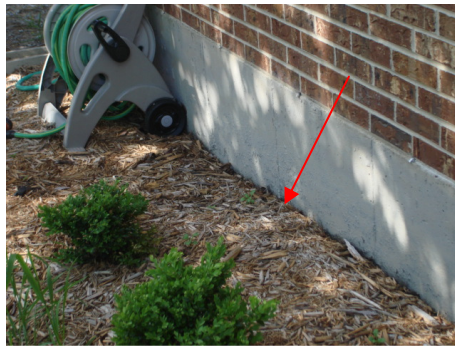
Negative grade on north, south, and west.

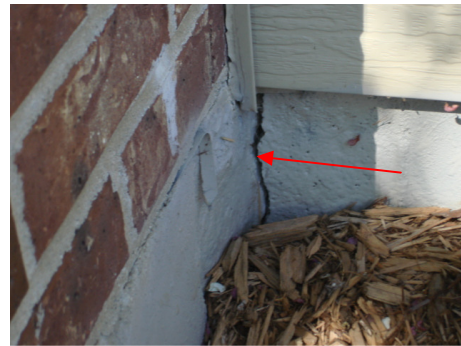
Fill crack in foundation on the east side of home.

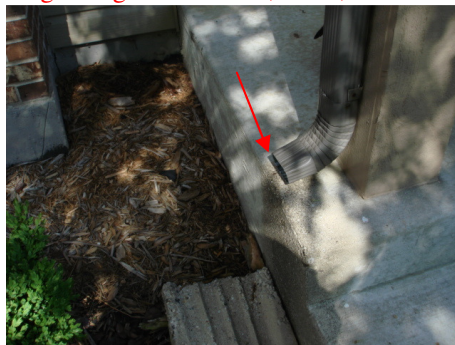
Extend all downspouts.

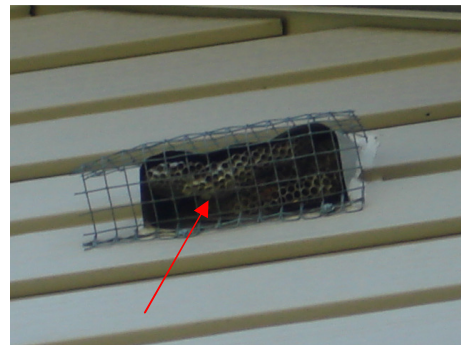
Bees nest in vent on the south side.

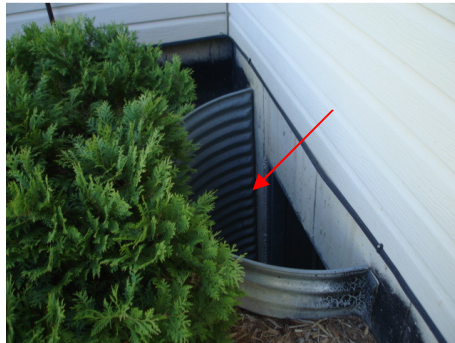
Missing window well cover west.

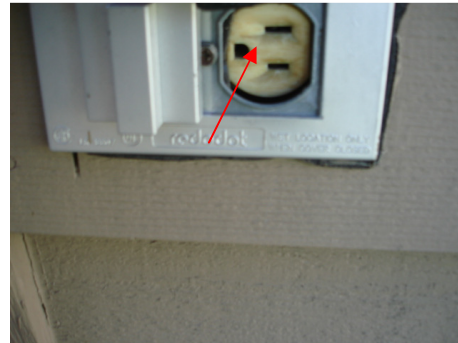
GFCI outlet needed on the back deck.

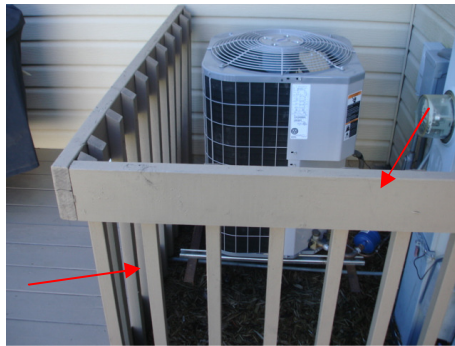
**Grounds:** Railings and balusters loose around the AC SAFETY CONCERN.

Railings and balusters loose around AC.

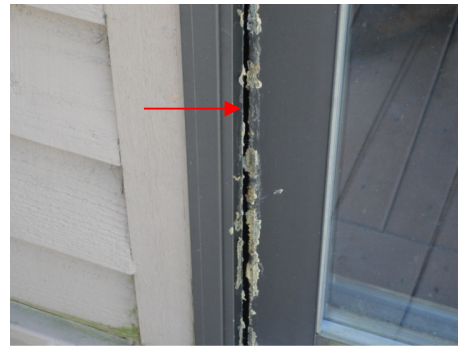
Gap in sliding door on back deck.

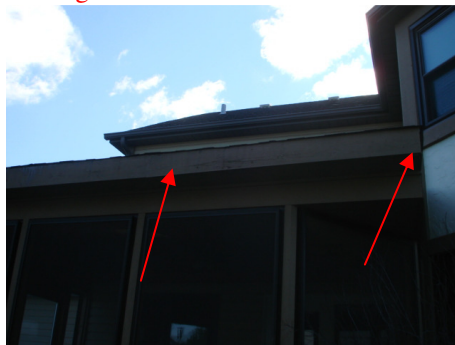
Missing gutters and downspouts on back porch.

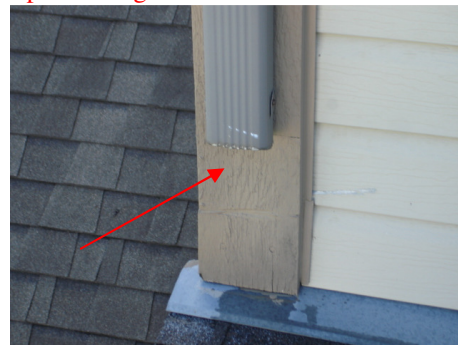
Missing extension elbow on upper west side of home.

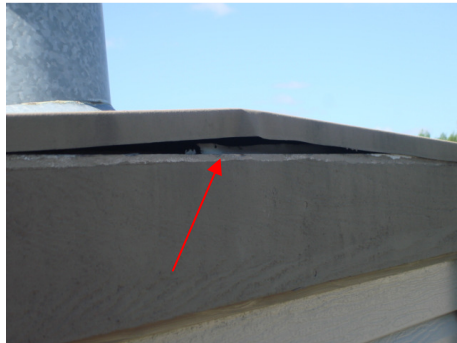
Chimney cap is bent.

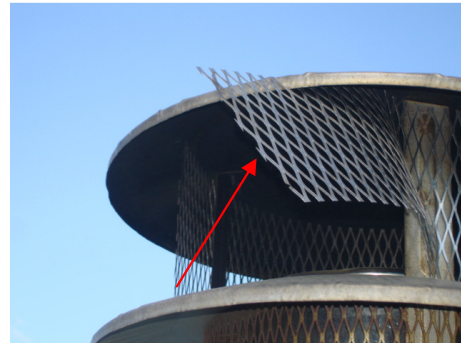
Wire loose around rain cap on chimney.

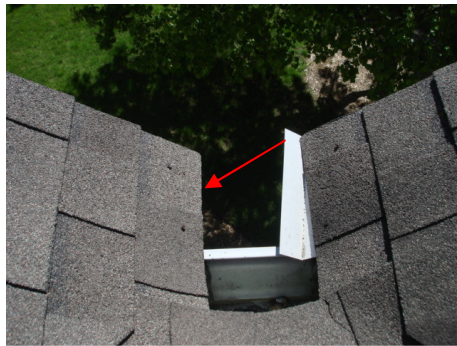
**Roof:** The middle peak on the east side of the home was missing some flashing that leads to the gutter line, repair or replace.

Missing flashing on middle peak of roof.

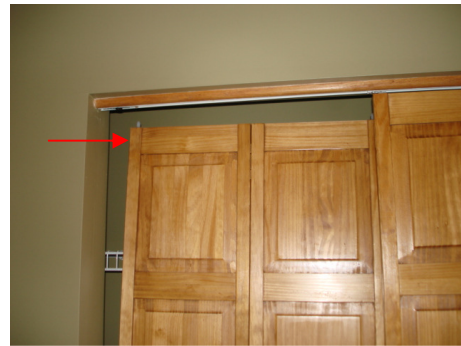
Pantry door not installed in kitchen.

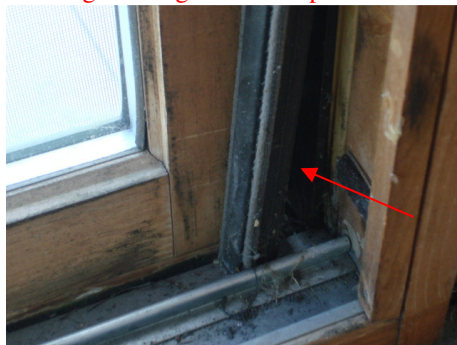
Weather-stripping not attached on sliding door on back porch.

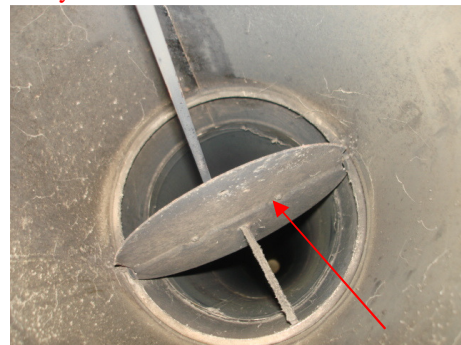
Damper not closing on fireplace flue.

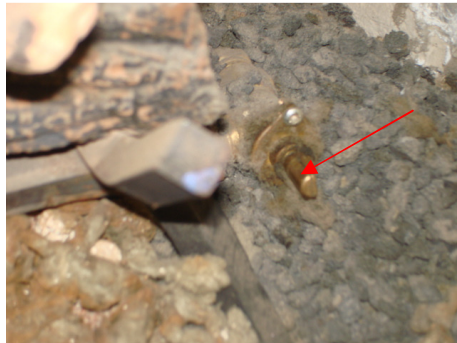
Extend gas valve for fireplace.

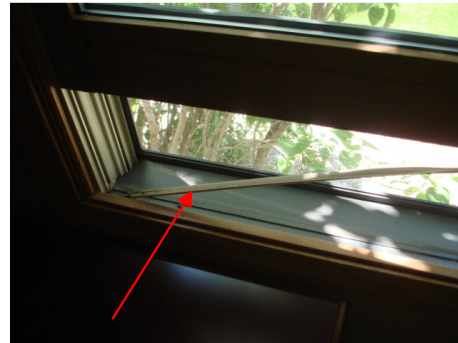
Loose weather-stripping on office window.

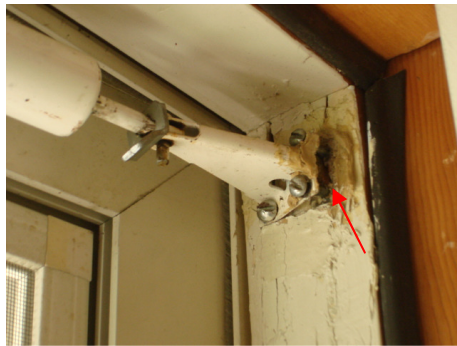
Loose hinge on front screen door.

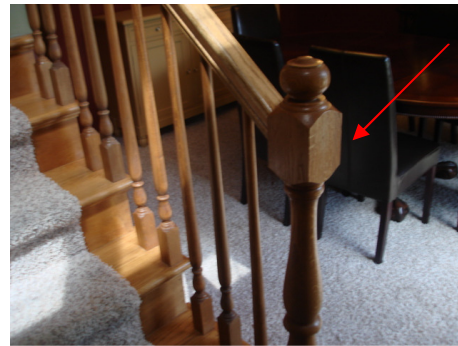
Railing loose leading upstairs.

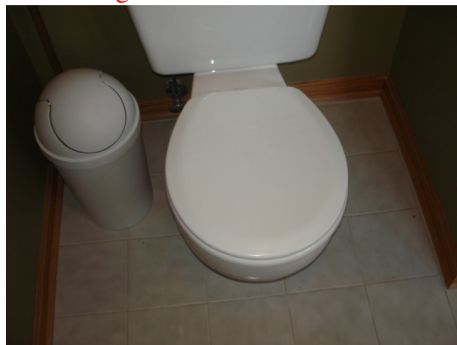
**Hallway Bath:** The toilet bowl was loose and may need to be reset. The toilet bowl was leaking and the water line and needs to be repaired or replace.

2<sup>nd</sup> floor toilets loose and hallway toilet is leaking.

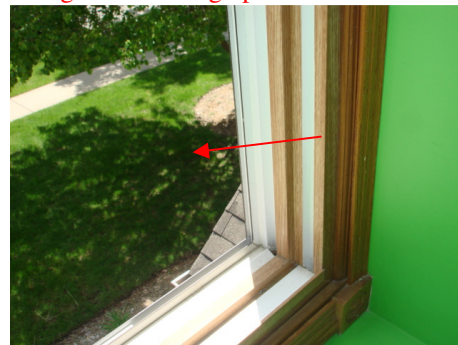
Missing screen in NE bedroom.

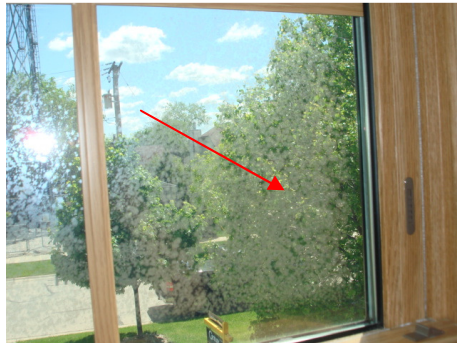
Seal broken on NE bedroom window.

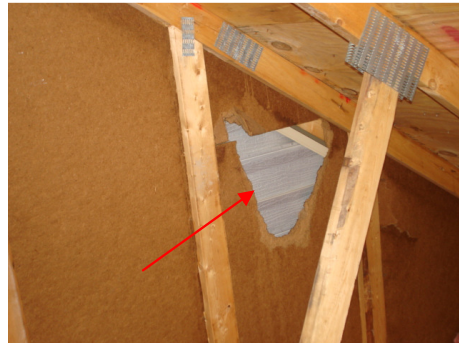
Missing backer board on the north side of attic.

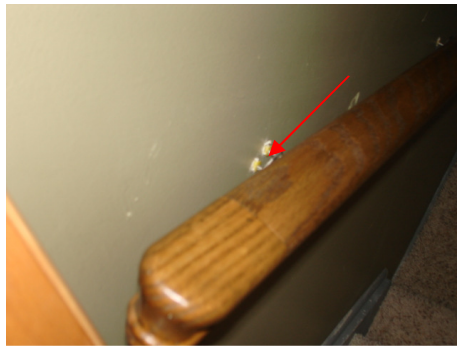
Loose railing leading into basement.

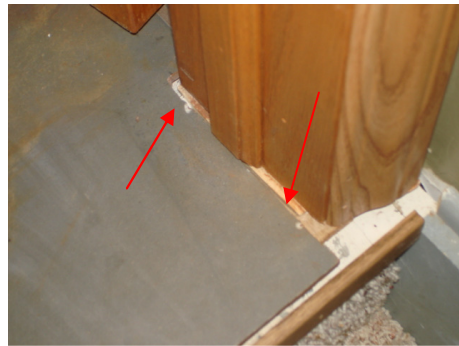
Missing caulk around basement door jam.

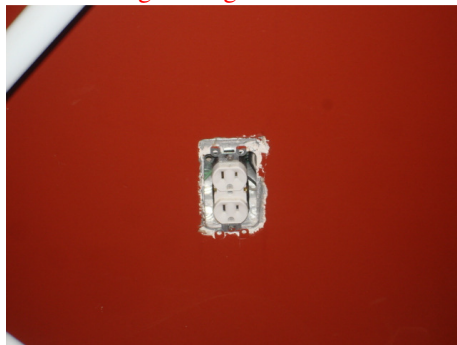
Outlet covers missing in basement.

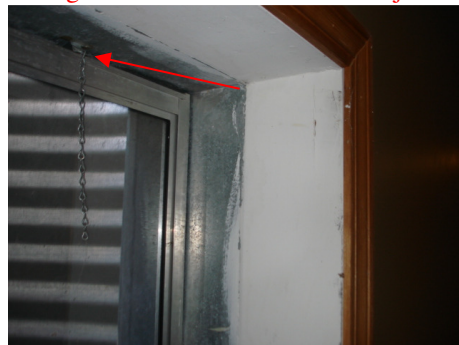
**Basement:** The fire escape window is not opening correctly; recommend sanding down drywall **Safety Issue:**

Fire window not functioning in basement.
